Bonners Ferry, Idaho—Water Year 2011	
By Ryan L. Fosness	
Prepared in cooperation with the Kootenai Tribe of Idaho	
Data Series 694

Fosness, R.L., 2013, Bathymetric surveys of the Kootenai River near Bonners Ferry, Idaho, water year 2011: U.S. Geological Survey Data Series 694, 26 p.

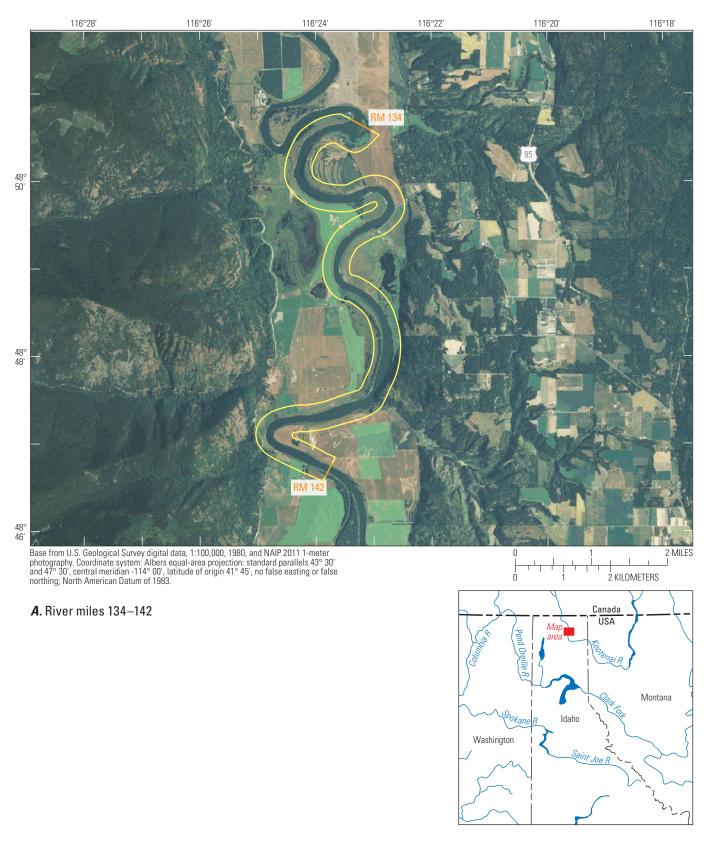
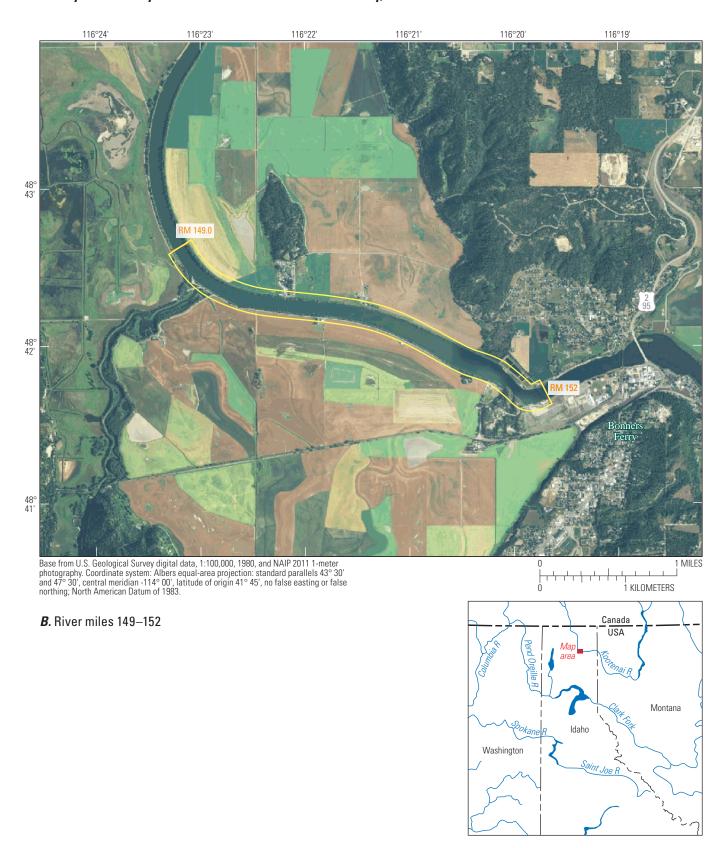
Figure 3. Extent of the surveys in unmapped portions of the meander reach, near Bonners Ferry, Idaho, water year 2011.

Bathymetric data were collected within an 11-mi reach of previously unmapped areas in the meander reach to obtain high-resolution bathymetric data. The extent of the surveys was from RM 134 to 142 (fig. 3A) and RM 149 to 152 (fig. 3B).

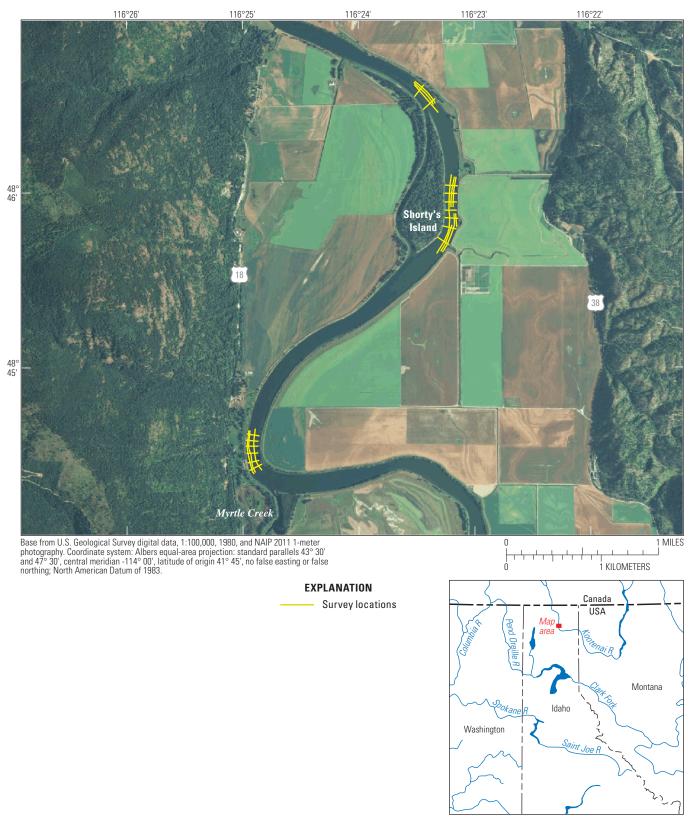
Figure 4. Extent of the Shorty's Island and Myrtle Creek substrate enhancement study area, near Bonners Ferry, Idaho, water year 2011.

Bathymetric data were collected in the Shorty's Island and Myrtle Creek substrate enhancement study area in the meander reach. The extent of these surveys was near RM 143.5 and 142.9 near Shorty's Island and at RM 146 near the Myrtle Creek confluence with the Kootenai River (fig. 4). The data-collection efforts described in this report are part of a long-term monitoring program to identify the spatial and temporal distribution of sand in the stream channel. This baseline survey was initiated to survey both the short- and long-term distribution of sediment in the study area. The planned survey lines were created as both cross sections and longitudinal lines intended to be surveyed bi-annually as part of the long-term monitoring program.

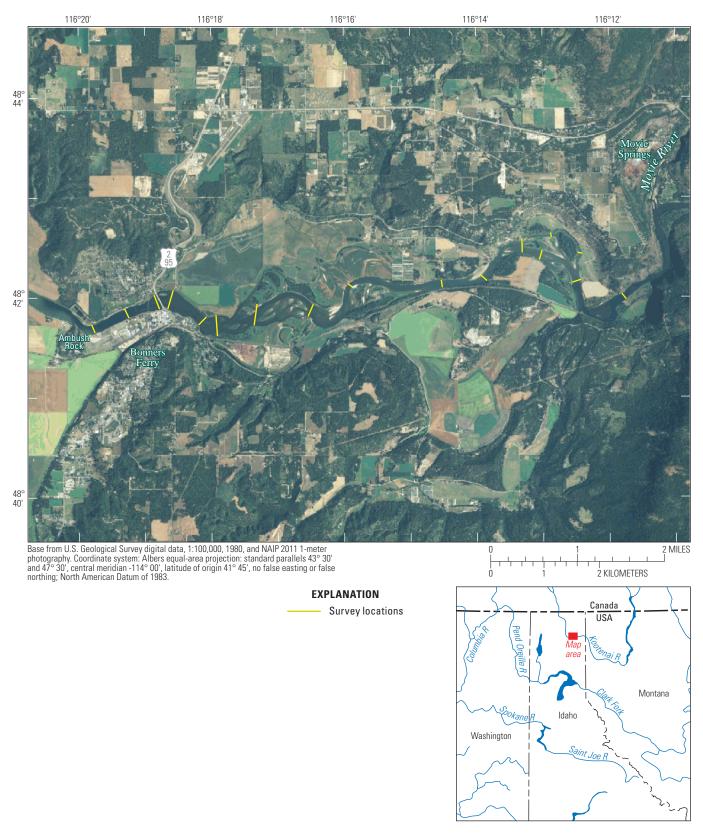
Figure 5. Extent of the braided reach cross-section survey area, near Bonners Ferry, Idaho, water year 2011.

Bathymetric data were collected within the braided reach as part of a long-term monitoring program. The extent of these surveys was near RM 152.2 near Ambush Rock upstream to approximately RM 159.1 downstream of the confluence of the Moyie River with the Kootenai River (fig. 5). The bathymetric data were collected at 17 cross sections to monitor aggradation and degradation of the channel bed to support on-going river restoration efforts in the braided reach.

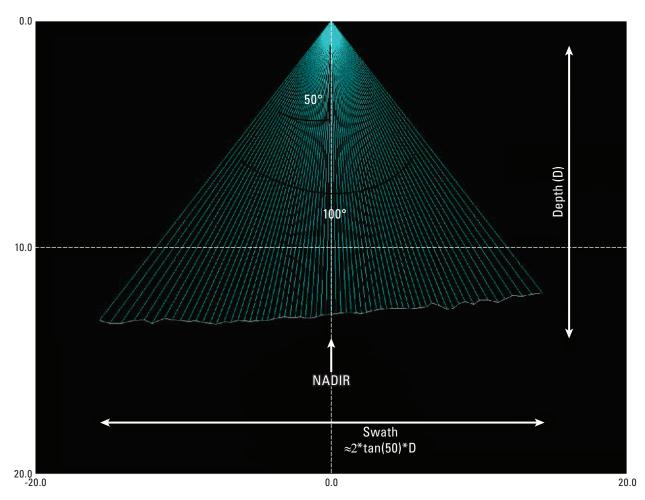
Figure 6. Example of the angular coverage and number of beams for the multibeam echosounder.

The bathymetric data were collected using a multibeam echosounder (MBE) system mounted on a USGS-owned and operated 25-foot jet boat research vessel. The echosounding component was a 240 kHz ODOM ES3 multibeam echosounder capable of projecting 120, 240, or 480 beams spanning a max of 120° swath (width of coverage). Figures 6 and 7 show examples of how the multibeam echosounder collects the corrected elevation point coverage across the survey swath. For the surveys on the Kootenai, 240 beams were selected and the port and starboard angles were limited to 50° per side for a total angular coverage of 100°.

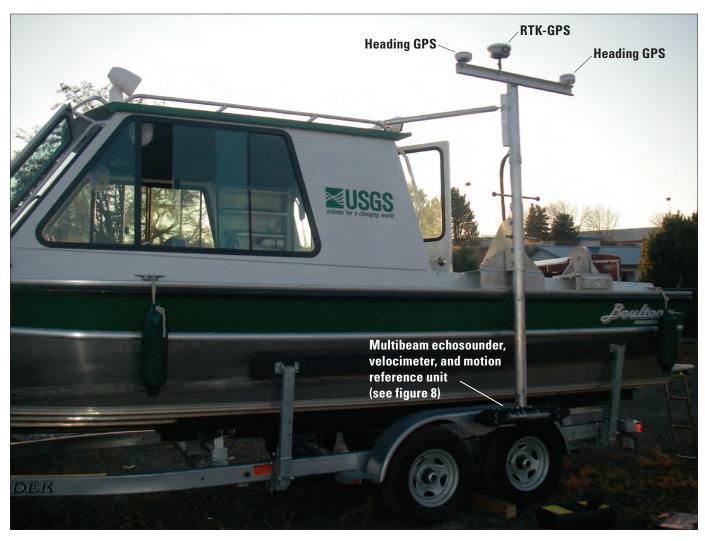
Figure 7. Multibeam echosounder components and mount on USGS research vessel.

A Teledyne TSS DMS-10 dynamic motion reference unit accounted for heave, pitch, and roll of the vessel. Two Digibar Pro sound velocity probes (velocimeters) were used to profile the speed of sound underwater. One velocimeter was mounted and operated real-time near the MBE to account for spatial change in the surface speed of underwater sound. The second velocimeter was used to acquire a depth profile that recorded how the speed of underwater sound varied by depth. A Trimble® R8 GPS receiver mounted over the MBE was radio linked to another GPS receiver set over a survey control point on land to provide real-time horizontal and vertical positioning. A Hemisphere® VS111 dual-GPS system was used for the heading and to output a 1 pulse per second (1PPS) output. The entire MBE system is shown in figures 7 and 8.

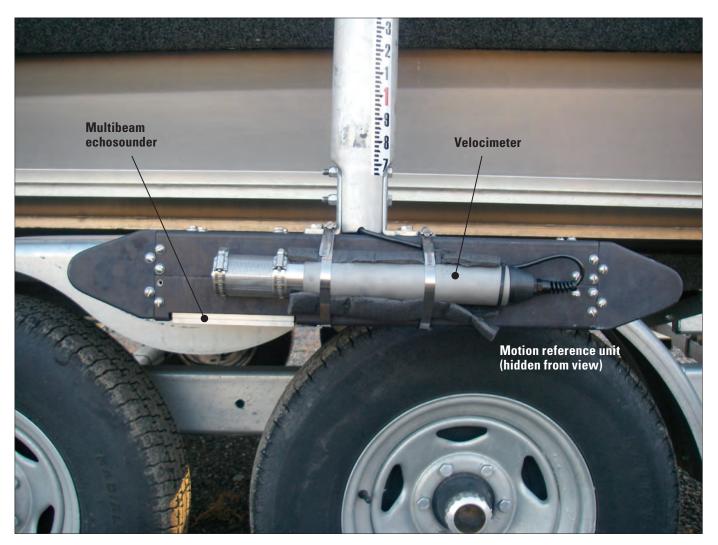
Figure 8. Close-up view of the submerged components of the multibeam echosounder.

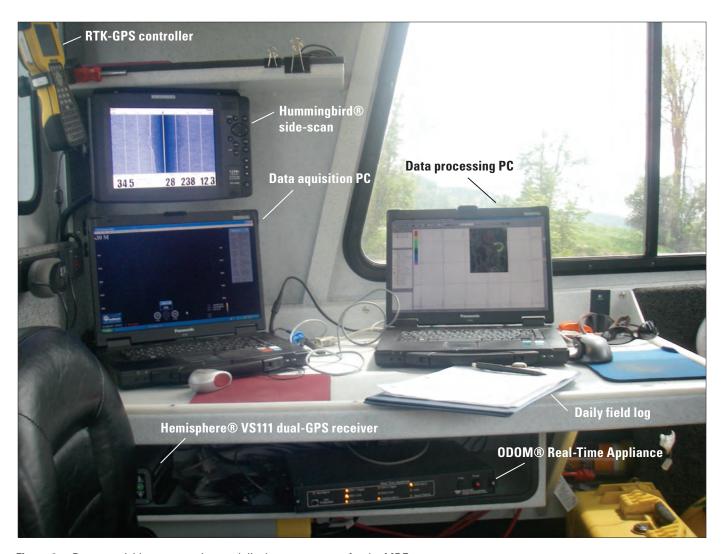
Figure 9. Data acquisition, processing, and display components for the MBE system.

An ODOM® Real-Time Appliance (RTA) was used to time stamp the MBE, motion reference unit, real-time velocimeter, RTK-GPS positioning and elevation, and precise heading data to within 1 millisecond based on the 1PPS signal from the Hemisphere® VS111. The RTA output the bathymetric data to two laptops, one for data acquisition and one for data processing. In addition, a Hummingbird® side-scan was used for qualitative purposes to verify and note unique features (trees, sunken cars, sand dunes, clay steps and benches) to the channel bathymetry. A daily field log of the bathymetric surveys was kept to record the equipment used, crew members, referenced survey bench marks, sound velocity profiles, file names, and other ancillary information. An example of the daily log is provided in appendix A. Figure 9 shows an image of each of these components.

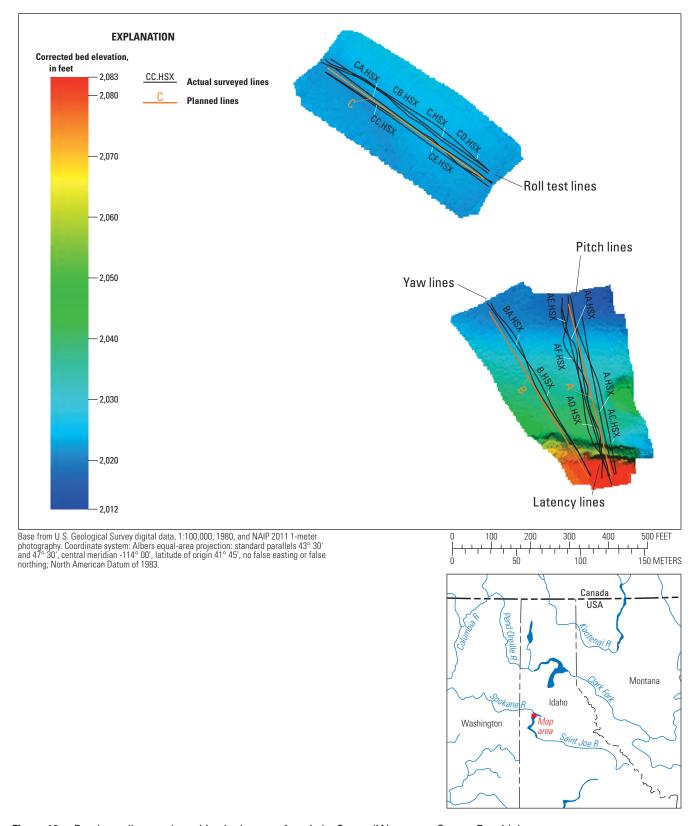
Figure 10. Patch test lines and resulting bathymetry from Lake Coeur d'Alene near Cougar Bay, Idaho.

Perhaps the most significant quality-assurance element is the patch test (table 1). A patch test included running a series of MBE survey lines to compensate for physical mounting differences including latency, pitch, roll, and yaw (fig. 10). Two patch tests were conducted before and after the surveys to ensure the MBE system was correctly offset and calibrated (appendixes D and E). A complete description of the patch test process can be found in U.S. Army Corps of Engineers (2004) and National Oceanic and Atmospheric Administration (2011). The offsets from the patch test were applied to the system prior to the surveys on the Kootenai River. A second patch test was conducted after the Kootenai River bathymetric surveys to ensure the system was still properly aligned and no adjustments to the offset coefficients were necessary. Neither of the patch tests were completed on the Kootenai River, due to the poor channel geometry and river currents that are not appropriate for a patch test.

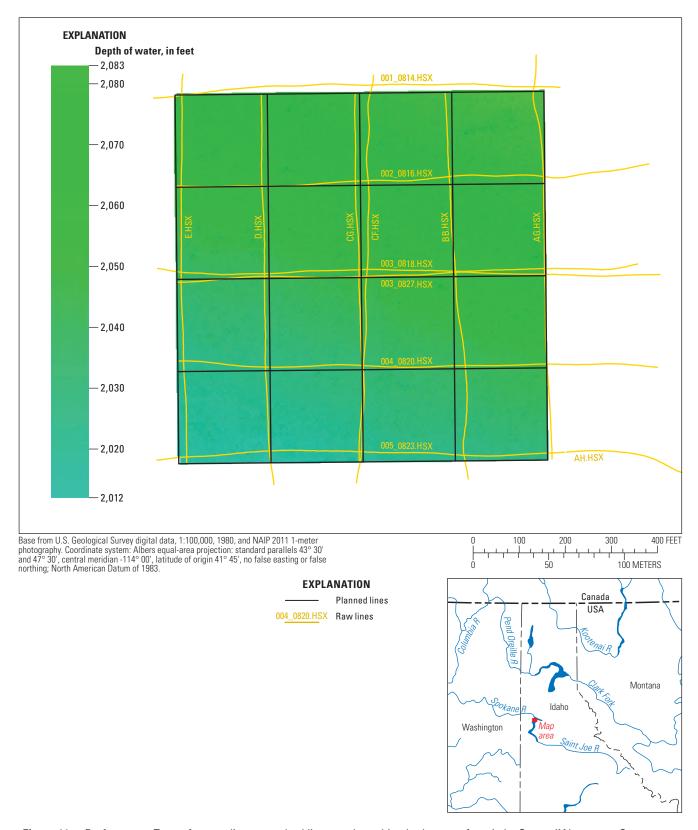
Figure 11. Performance Test reference lines, standard lines, and resulting bathymetry from Lake Coeur d'Alene near Cougar Bay, Idaho.

Following the adjustments from the patch test, a performance test (also referred to as a beam angle check) provided quality control by quantifying the accuracy of the MBE (fig. 11). The performance test compared a set of standard survey data against a known reference surface. The reference surface was created by surveying 10 lines (5 parallel and 5 perpendicular) spaced equal to the depth creating 200 percent overlap and edited to remove any data outside of 45° from the NADIR beam. The final reference surface is the best representative surface for a baseline measure to check the performance of the system. Two standard survey lines were surveyed across the center of the reference surface to be used as the performance measure. The standard survey lines were edited using the same methods applied to all data collected. The performance test for the Kootenai River bathymetric surveys was conducted on April 28, 2011, at Lake Coeur d'Alene, Idaho. It was recommended that the performance test be done on the same body of water as the study, but there

was not a suitable location within the Kootenai River for the performance test. The output from the performance test includes a summary of how the accuracy of the X,Y, and Z data are distributed through the swath of the MBE. Typically, the integrity of the data is diminished as it deviates from the center (NADIR) beam. The results of the performance test were compared with the minimum performance standards as defined by U.S. Army Corps of Engineers (2004) and are shown in appendix F.
